CALIFORNIA INSTITUTE OF TECHNOLOGY

**THE SALONICA (THESSALONIKI) EARTHQUAKE
OF JUNE 20, 1978**

BY
IOANNIS PSYCHARIS

EERL 78-03

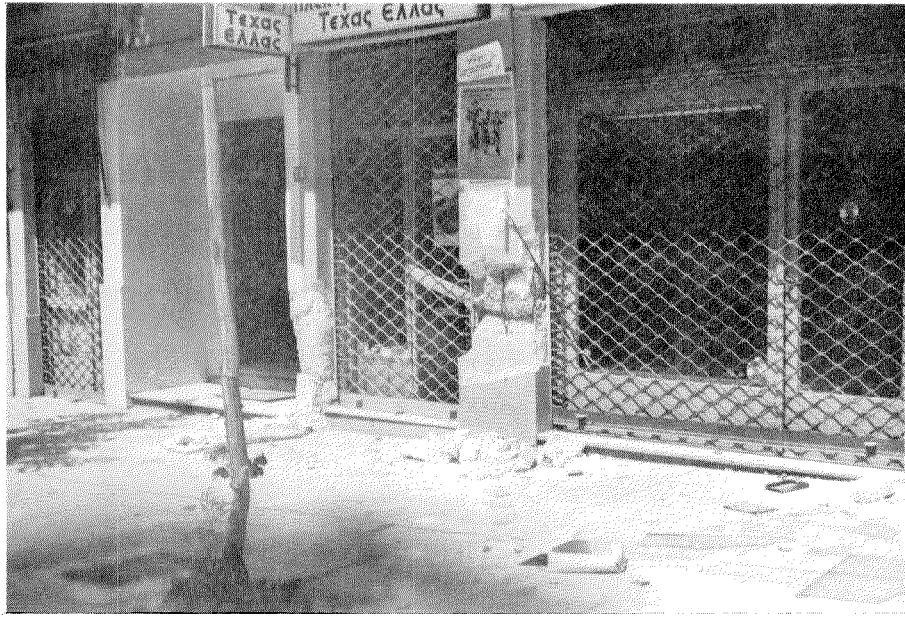
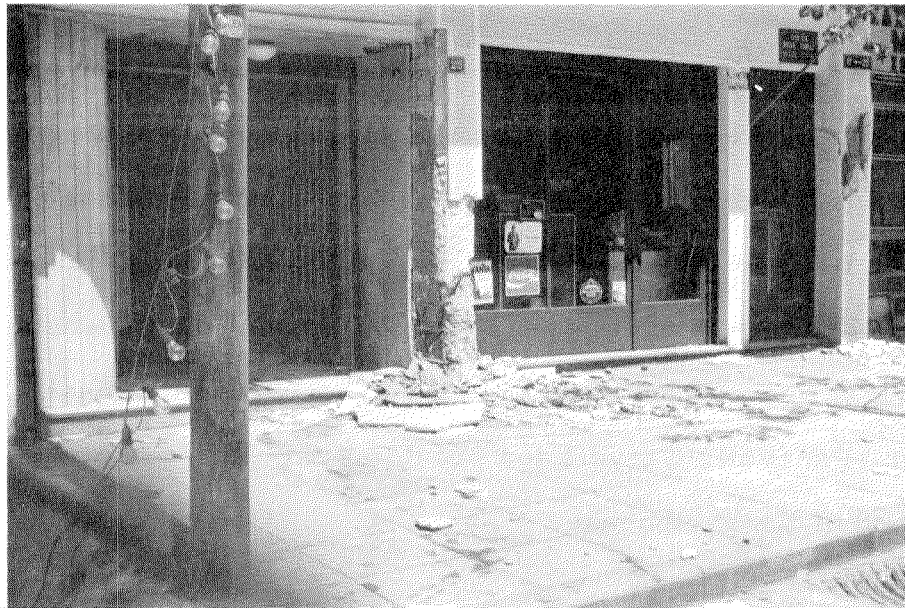
Two other apartment buildings on 23 and 25 Vasilisis Sofias street, of about the same height as the one which collapsed, were damaged to the point that they no longer could be occupied. The columns of these buildings were badly cracked above the ground surface and the steel reinforcing bars were bent (see figure 6a, b).

These buildings, like the one which fell, were built in the place of the old hippodrome, where the foundation soil was formed by fill. These poor foundation conditions might have played an important role in the

extent of the damage to these buildings. Other buildings in the same area also suffered considerable damage.

Figure 6. Severe damage to the columns of the buildings at 23 and 25 Vasilisis Sofias street.

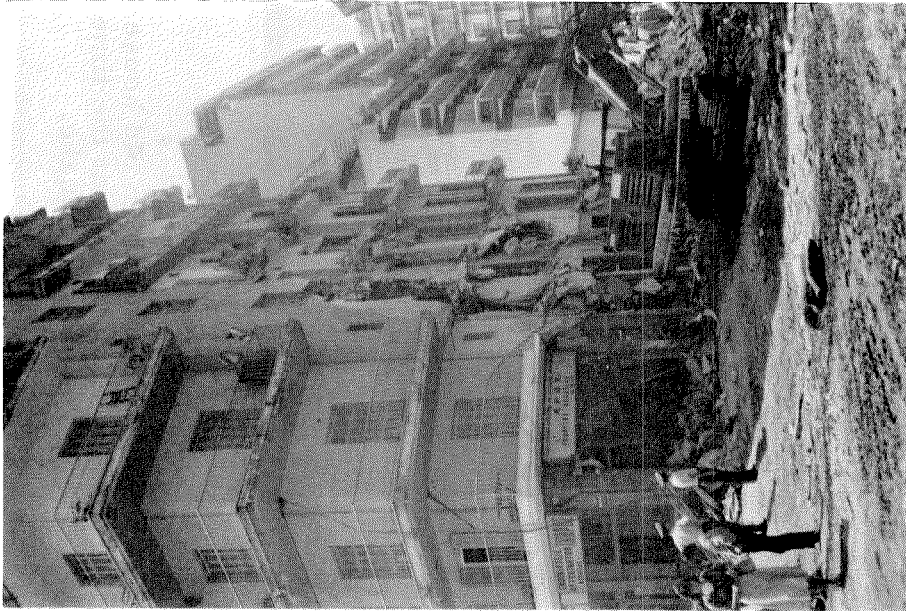
The 8-story apartment building, situated at the crossing of Nikiforou Foka and Ippodromiou streets, collapsed completely. Fortunately, 8 families who lived in the building had been on vacation at the time of the earthquake, otherwise the number of casualties would have been much higher. The building, which was an old one, was designed before the adoption of the modern building code. In any case, investigations started a few days after the quake in order to clarify the reason for the collapse.

Figure 7. Severe damage inflicted to adjacent buildings by the fall of the 8-storey apartment building at Ippodromiou street.

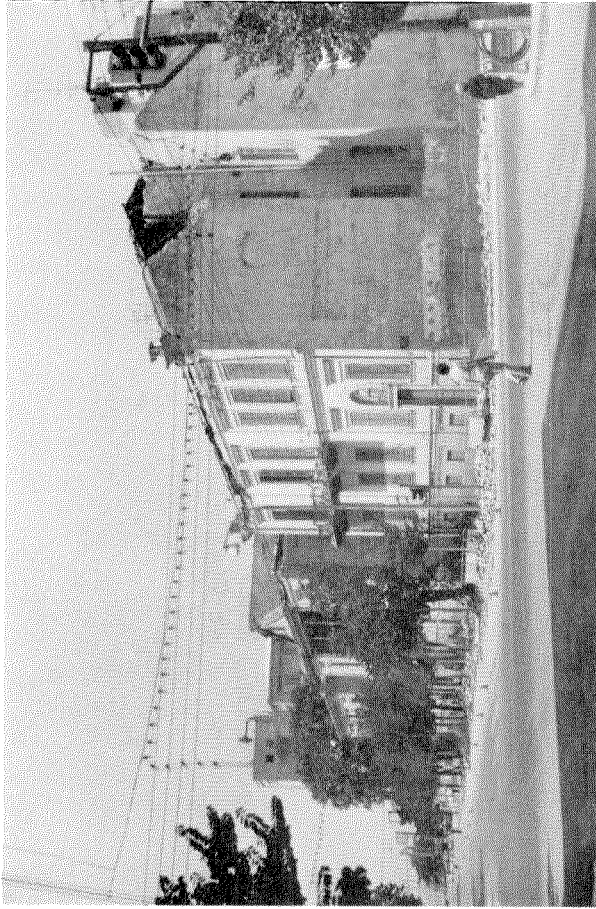
Figure 8. Damage to old buildings at Vasilisis Sofias street.

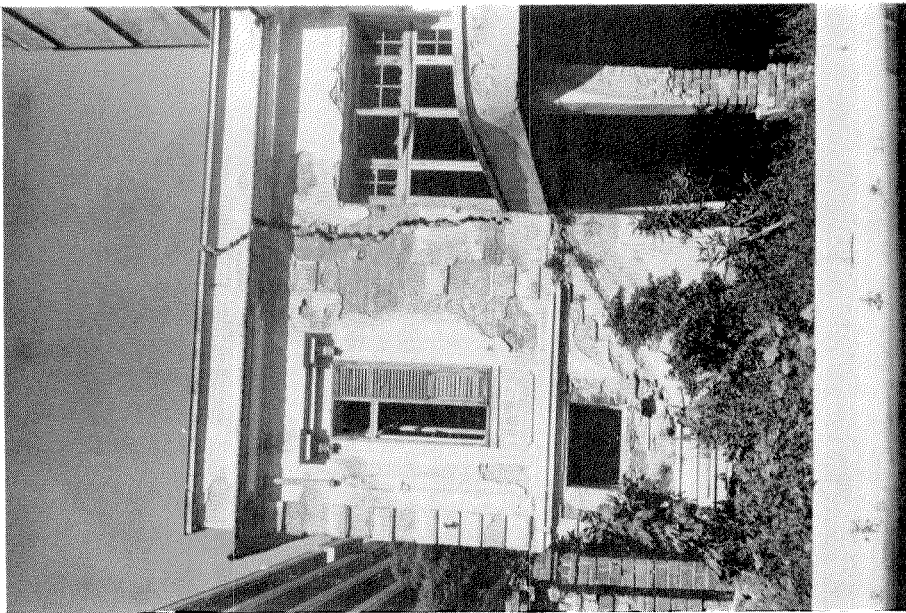
Figure 9. Damage to an old house not occupied at the time of the earthquake.

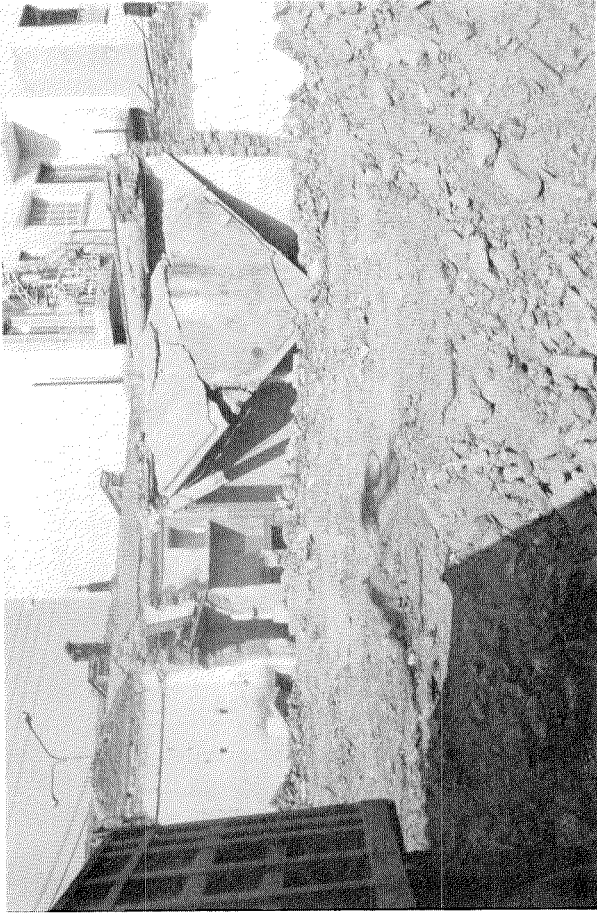
A lot of old weak houses were severely damaged, usually in the form of falling masonry. Walls fell down in such buildings, and the damage to the parapet walls and the balconies was also extensive. A 2-story house at Yiannitson street collapsed completely.

Figure 10. This was a 2-storey old house at Yiannitson street which collapsed.

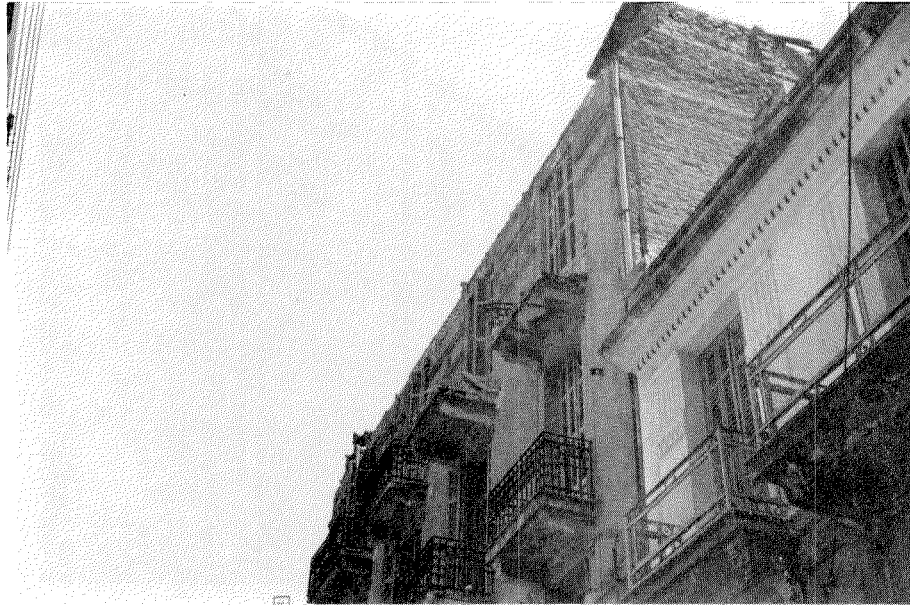
Figure 11. Damage to the parapet walls and the balconies of "Egyptos" Hotel.

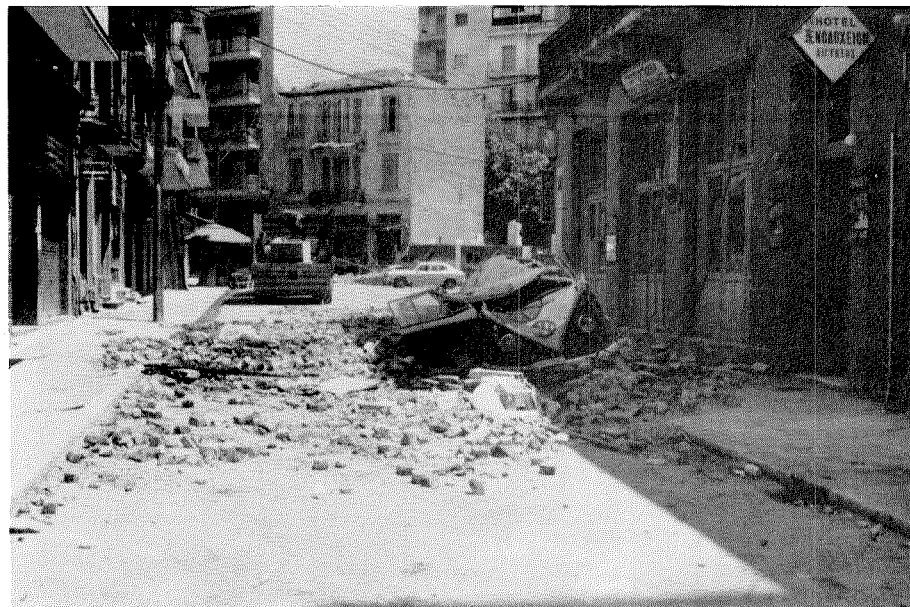
Figure 12. "Egyptos" Hotel. A person was killed here by falling bricks.

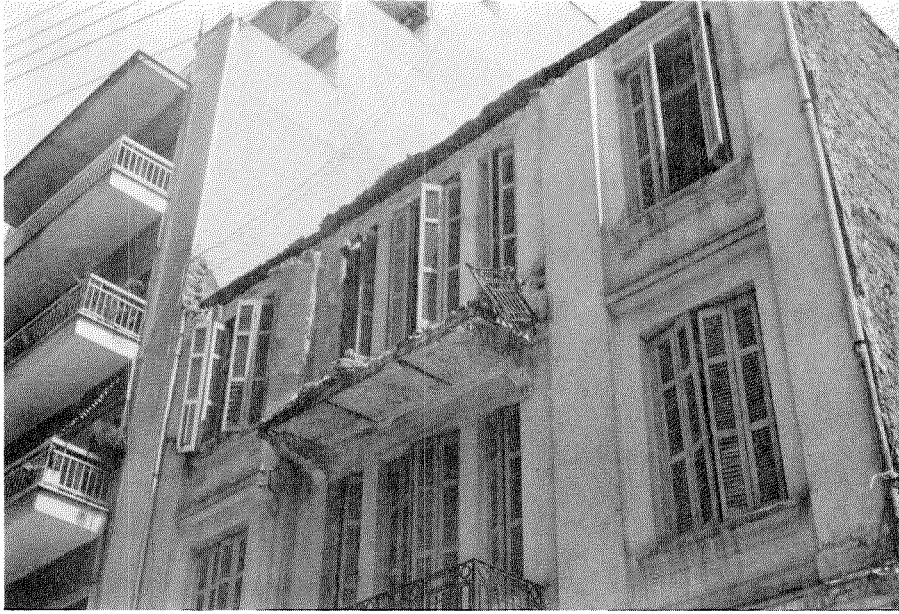
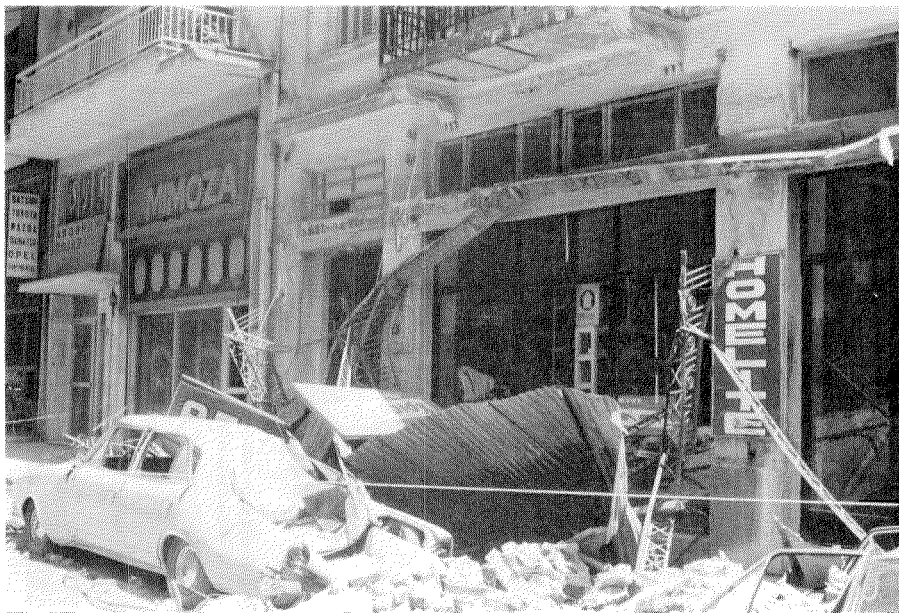
Figure 13. Damage to the balcony and parapet wall of an old house.

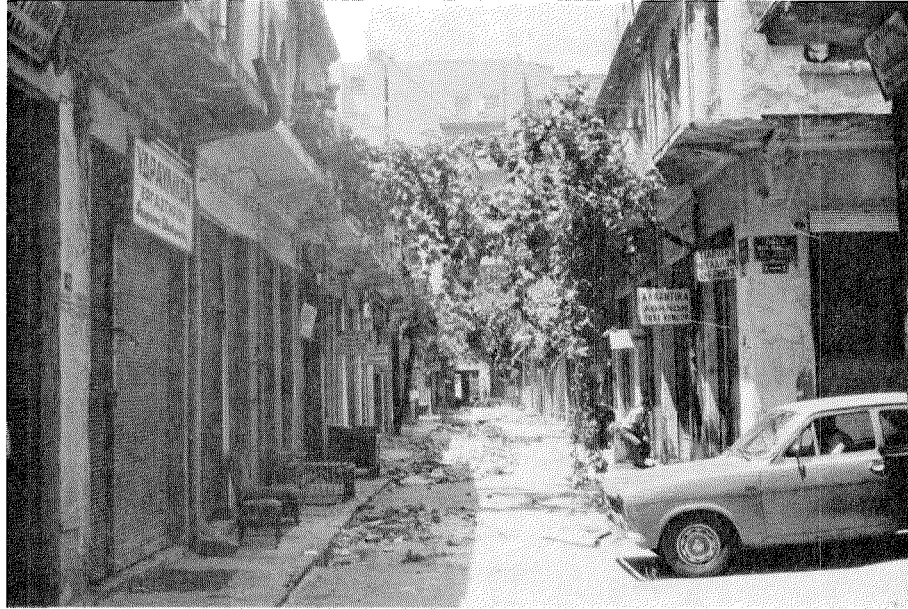
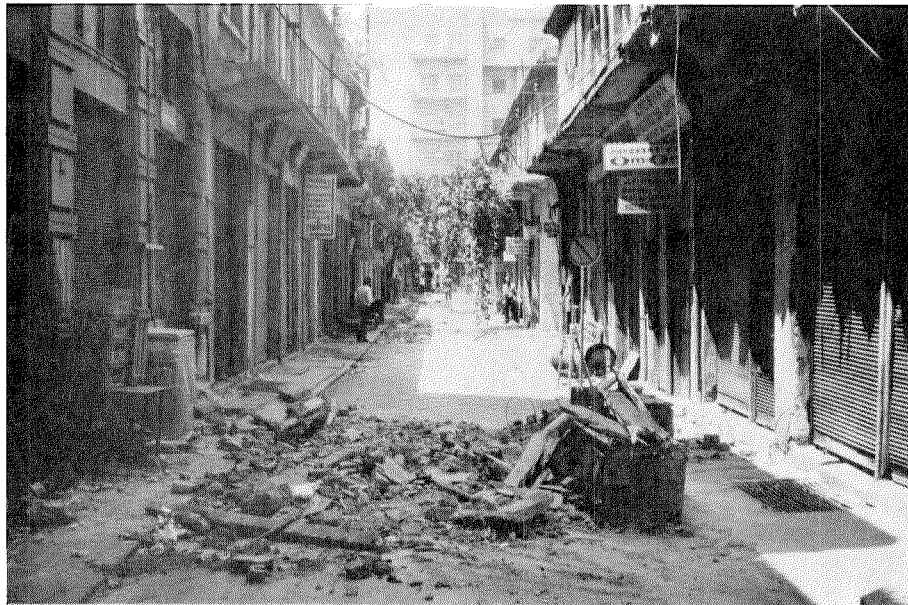
Figure 14. Extensive damage to the parapet walls and balconies of old houses.

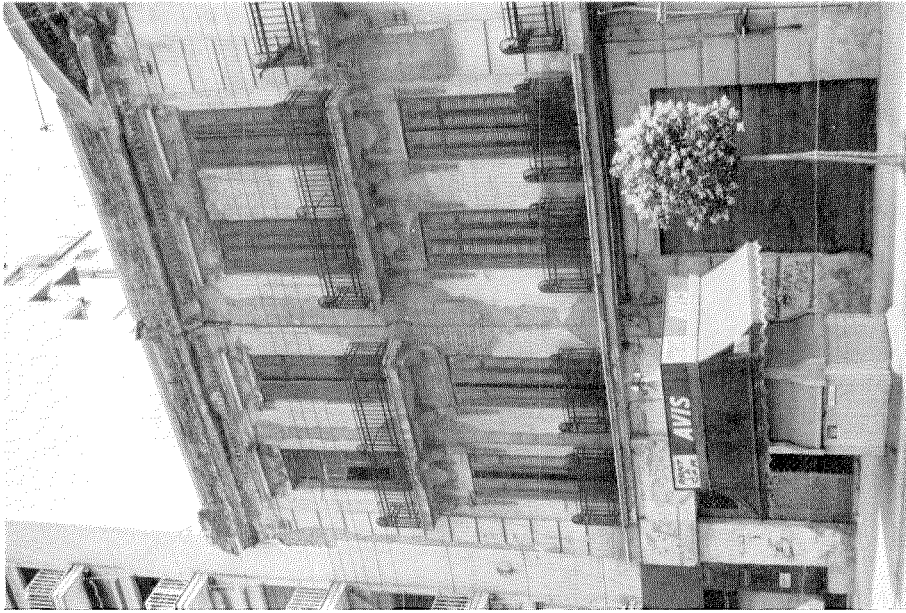
Figure 15. Separation of two old buildings after the earthquake.

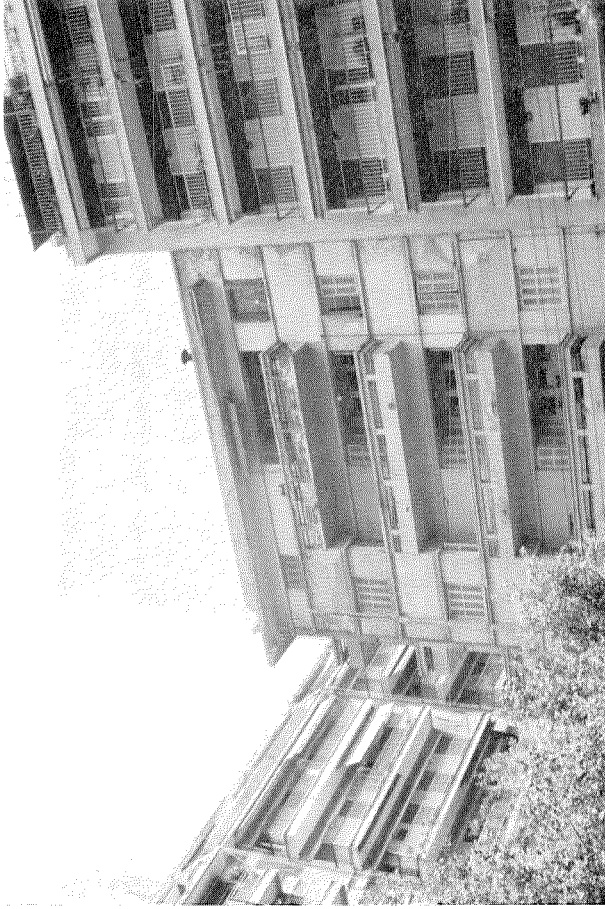
Figure 16. Damage to the plaster of the exterior walls. This kind of damage was very common.

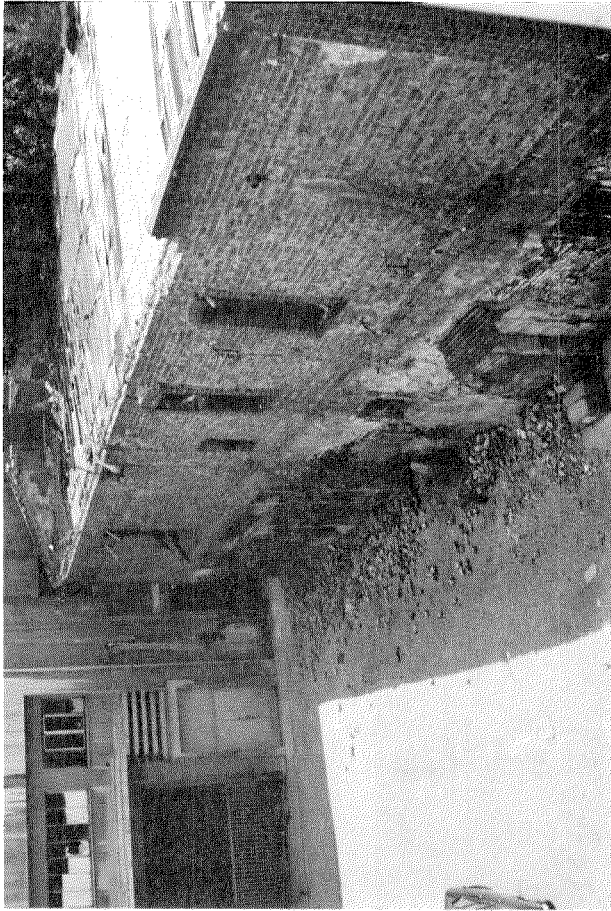
Figure 17. Damage to the parapet wall of an old building.

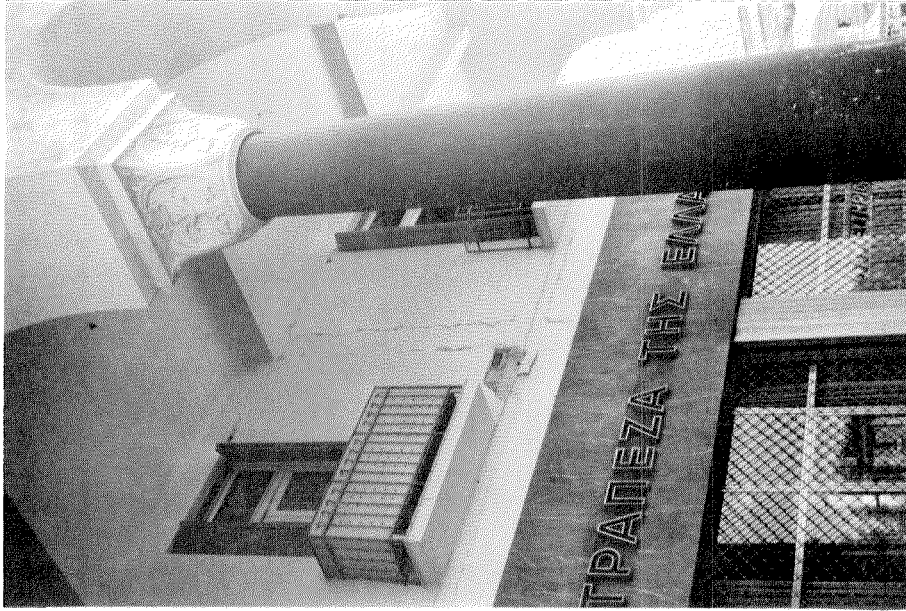
Figure 18. Cracks along the boundary of the concrete frame of a modern building.

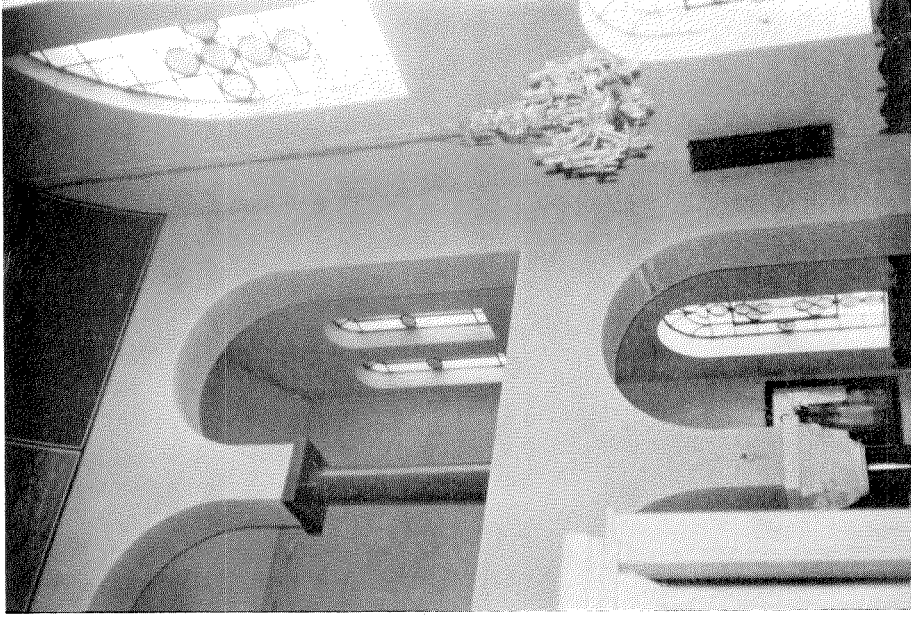
Figure 20. Church of Agia Barbara in Toumba. Cracks on the interior walls and arches.

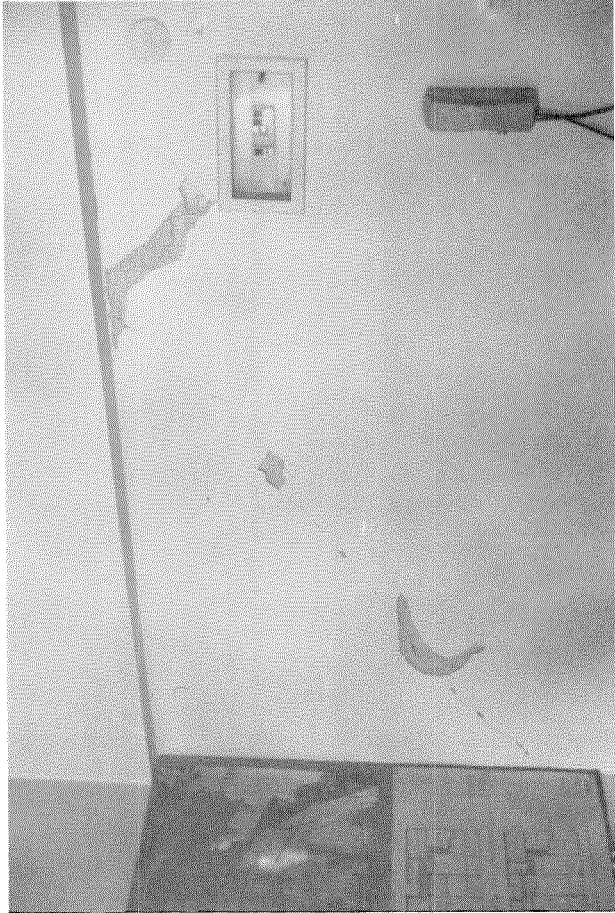
Figure 19. Cracks on an interior brick wall of a modern building.

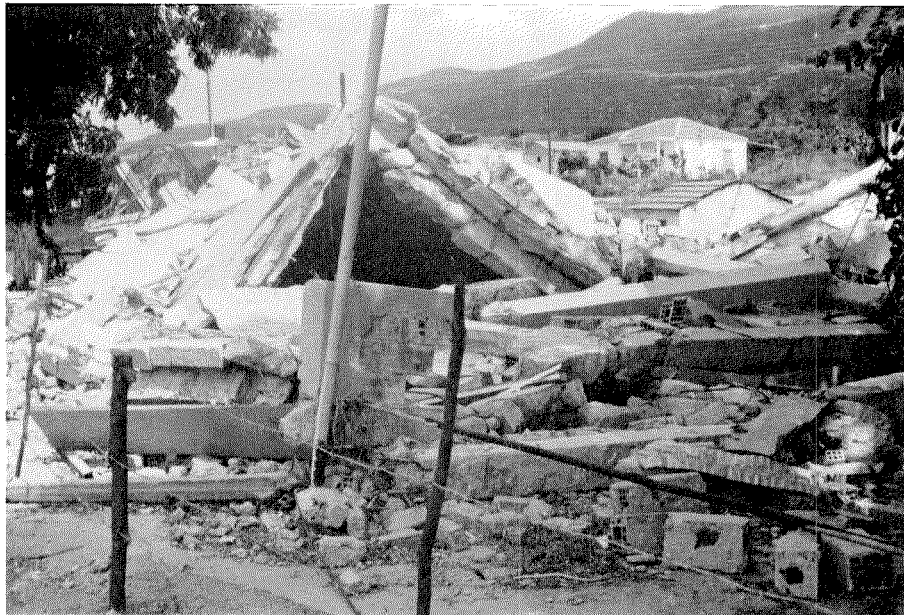
Figure 22. Collapse of a house at Stivos Village.

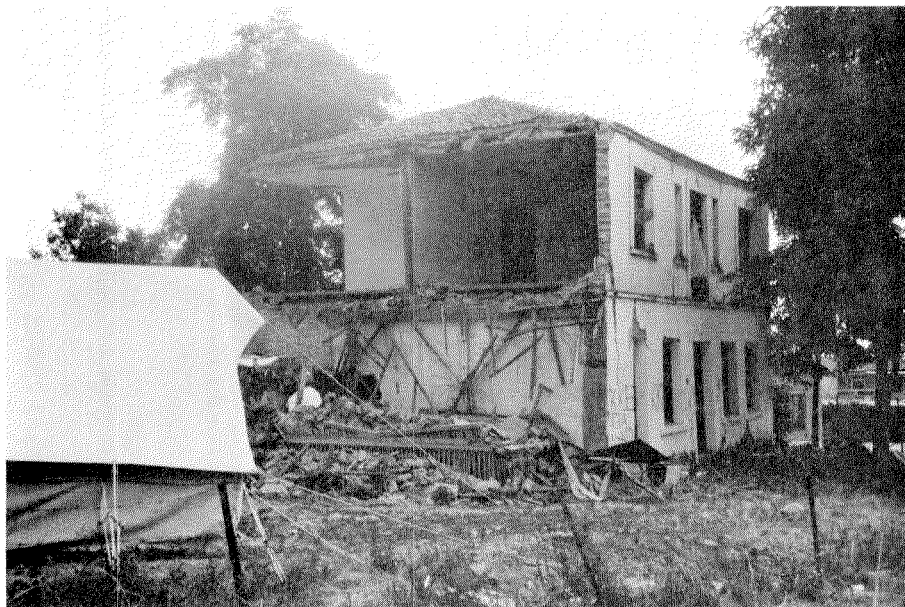
Figure 23. Fall of an exterior wall of a house at Stivos Village.

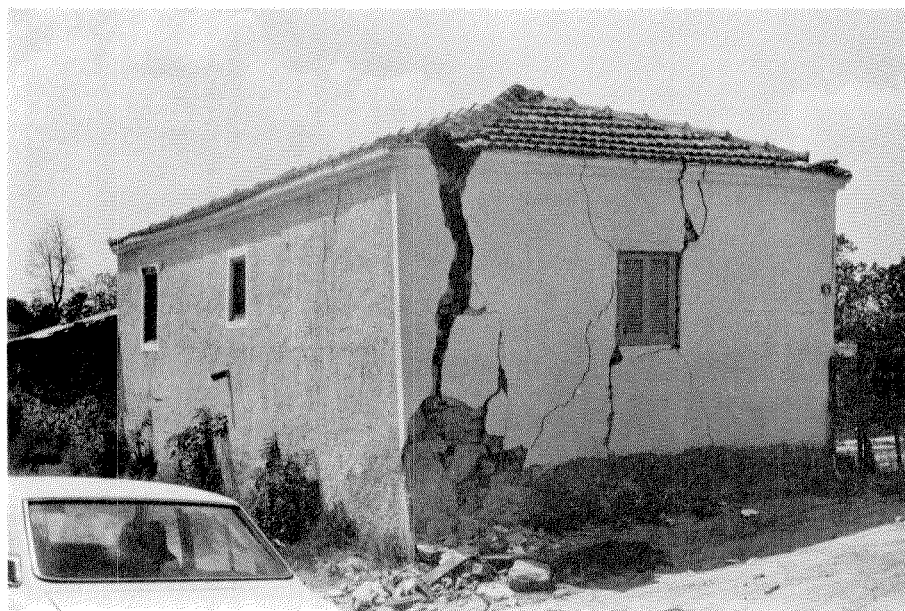
Figure 24. Typical damage to house at Stivos Village.

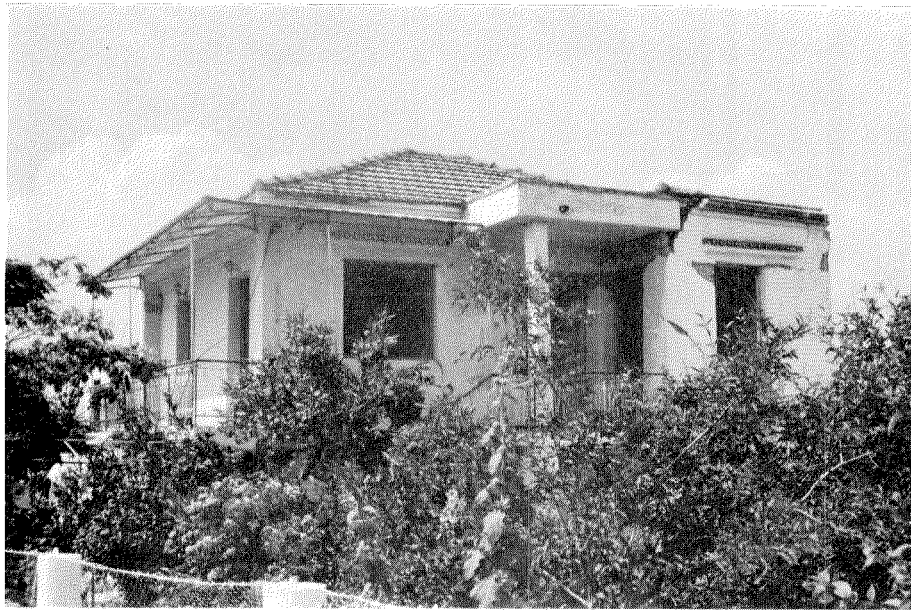
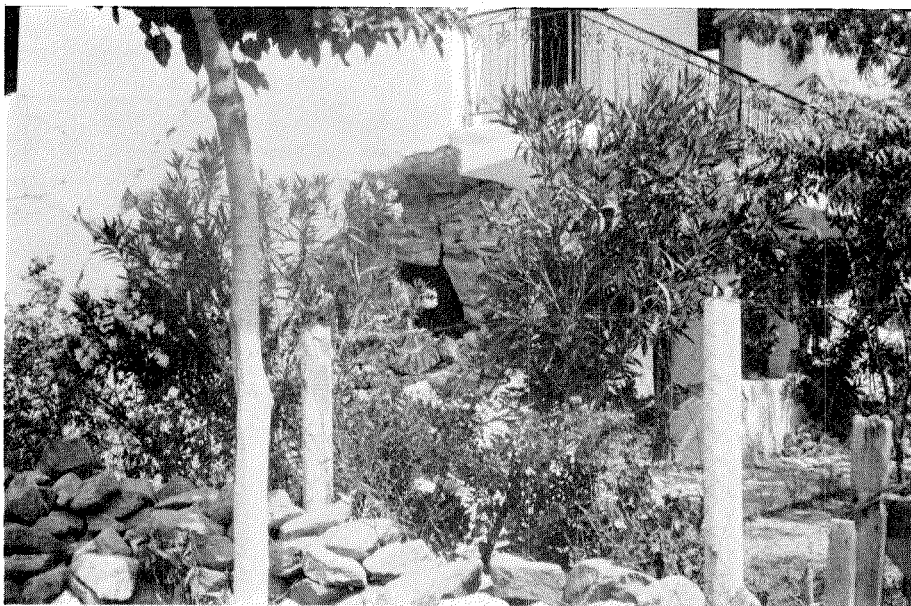
Figure 25. Damaged house at Stivos Village.

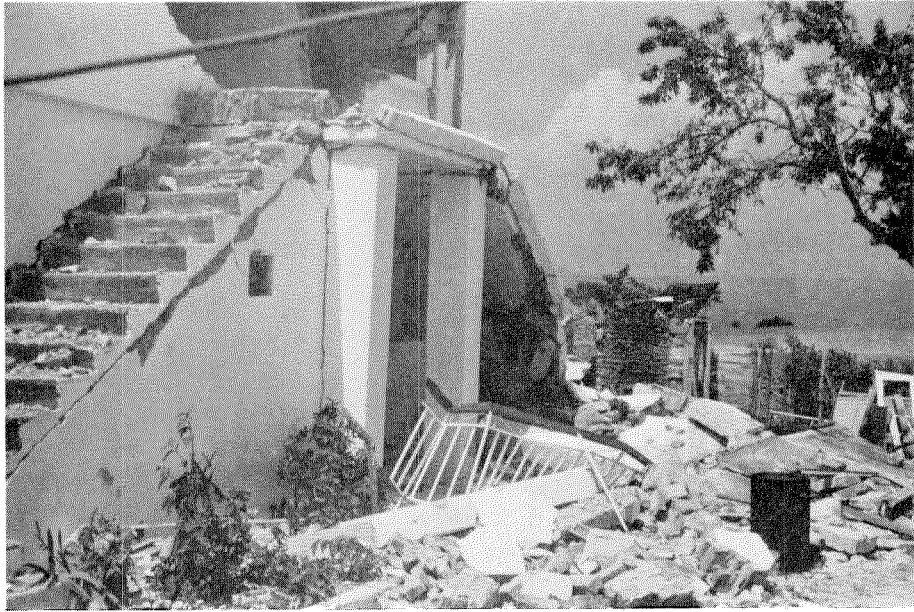
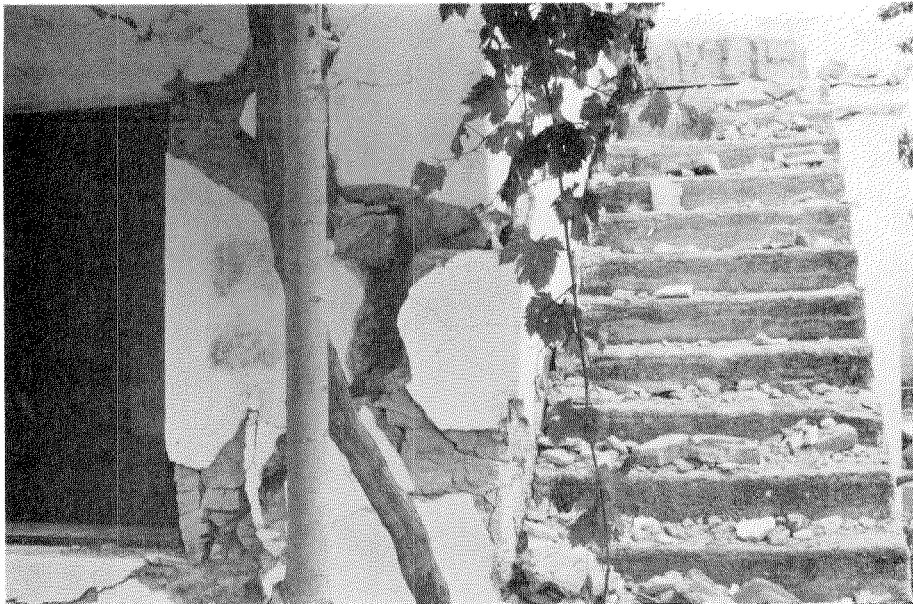
Figure 26. Damage to the stairway and the exterior wall of a house at Stivos Village.

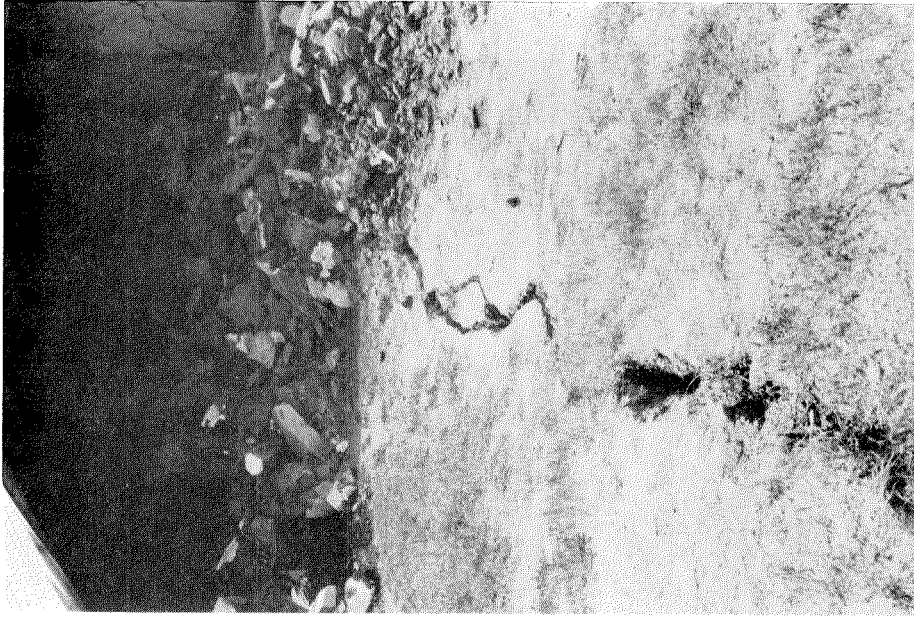
Figure 28. Crack which appeared on the earth at Stivos.

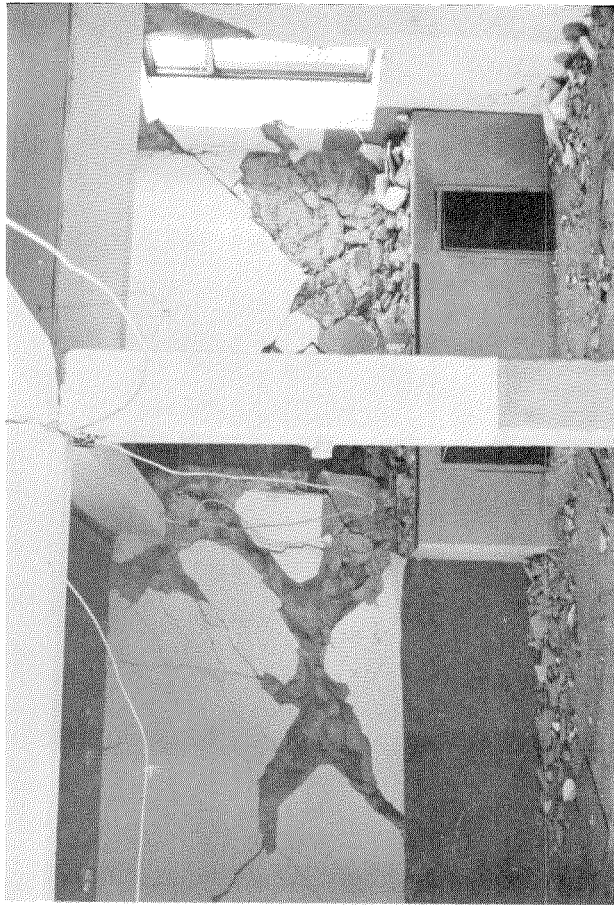
Figure 27. Damage to the interior of the same house.

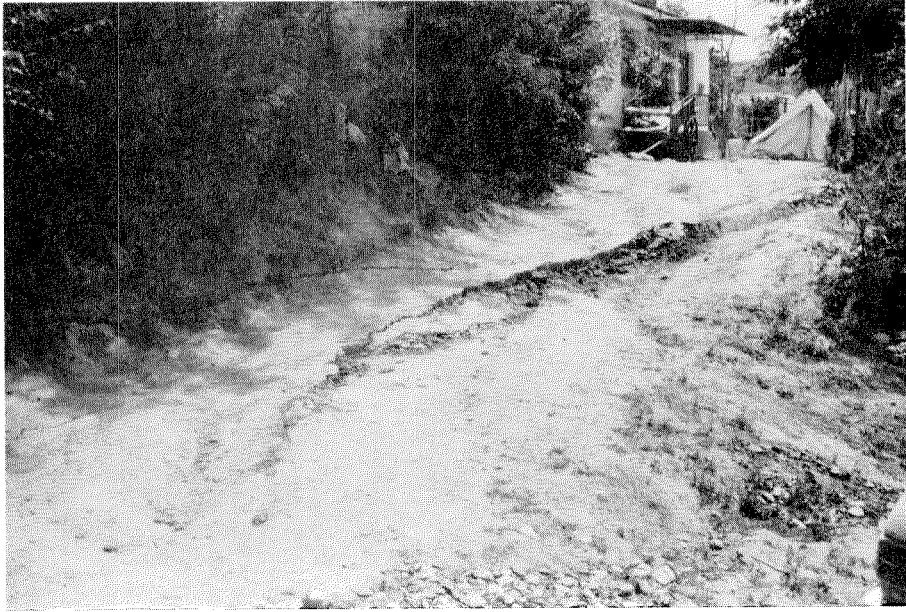
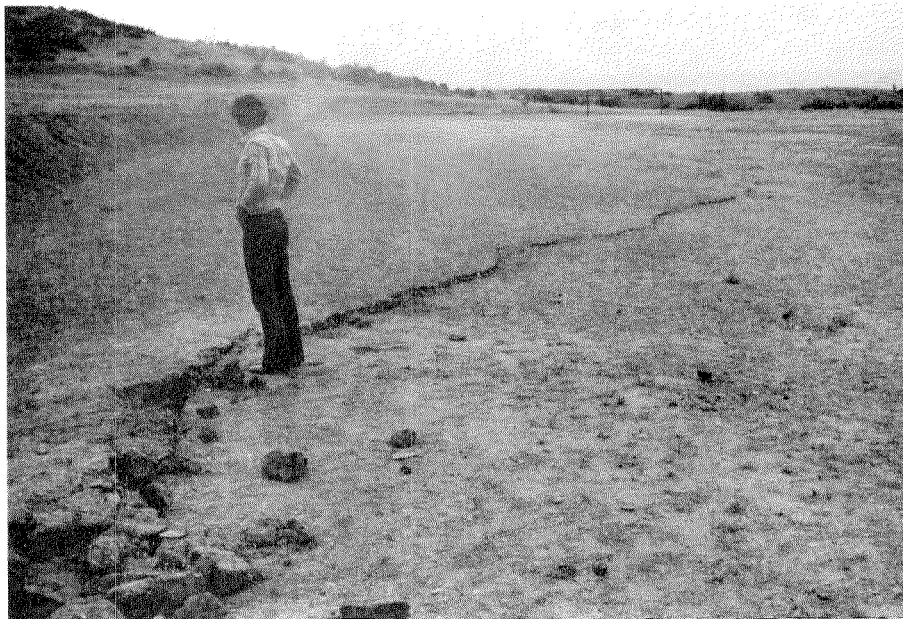
The earthquake produced a net of cracks, which appeared at two places in the epicentral region near the village of Yerakorou and between the villages of Stivos and Scholari. Near Yerakarou, the cracks were oriented E-W and the horizontal slipping was 2 cm. Between Stivos and Scholari, the cracks were oriented SE-NW with the same amount of motion. The width of the cracks in some places reached 20 cm. Local vertical slipping also occurred in some places, the maximum being 20 cm in a place at Scholari. As of mid-July, it was not known whether the cracks were related to faults or were merely local effects.

Figure 29. Cracks on the ground at Stivos.
